Transforming Lorne School into a Community-Supported Neighbourhood Asset: **A Feasibility Study**

exp Quality System Checks	
Project No.: SNB-00232403-A0	Date: September 23, 2016
Type of Document: FINAL	Revision No.: 0
Prepared By: Morgan J. Lanigan

Newman Street Facility - Building Condition Assessment

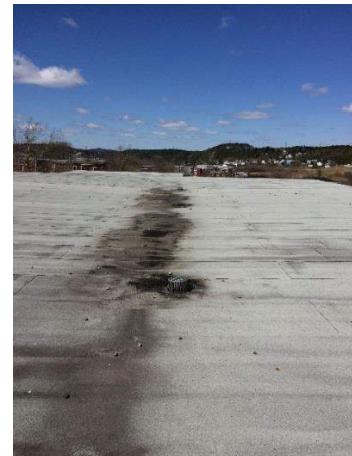
Photograph 2.2

It appears the flat roof slopes from the outer edges toward the centerline of the roof where two drains are located. Although there was no standing water at the time of the site visit, there is evidence that this does occur by the presence of water staining in this area (See Photograph 2.2). Efficient drainage relies on positive roof slopes to direct water to the drains. Water typically collects in low lying flat areas, often relying on wind and sun to dissipate the water within a couple of days. Introducing crickets at low lying areas when the roof is replaced would enhance the flow of water to the drains thus preventing standing water.

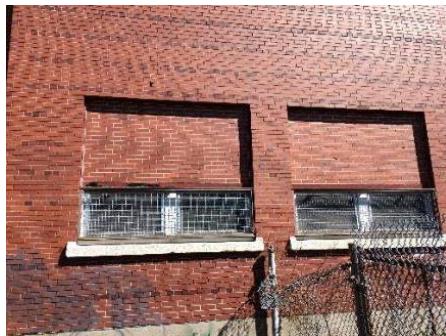
Photograph 3.1

Based on visual observations, some localized repairs should be carried out to the exterior wall systems in the near future. In general, this work should include: repairs to the deteriorated mortar joints and damaged brick masonry; cleaning brick façade of graffiti and rust staining; clean metal façade from atmospheric soiling; paint wood trim and replace; repair dented steel chimney flue and redo all exterior sealant.

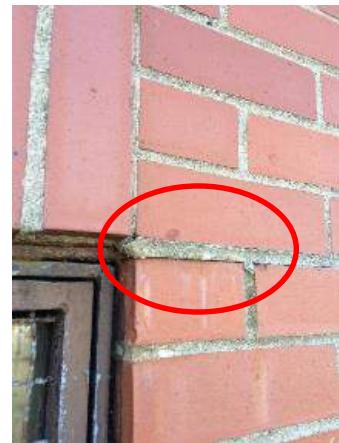
Photograph 3.5

3. There is localized deteriorated mortar joints at steel angle window lintels. (See Photographs 3.5 & 3.6). In addition to the expansion and contraction of the steel angle, water draining above the window angle is being trapped by the mortar and causing deterioration through freeze thaw cycle in addition to differential expansion and

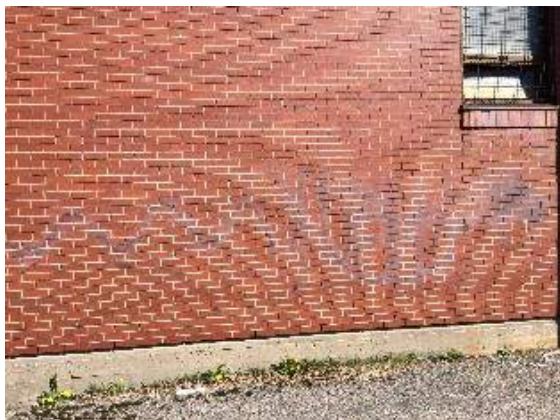
Photograph 3.8

5. There are localized areas of graffiti on the east and west elevations (See Photographs 3.8 to 3.10). Surface cleaning of the brick masonry is recommended in the next 5 -10 years) to avoid long term damage to the brick masonry, though immediate removal may deter repeat offences.

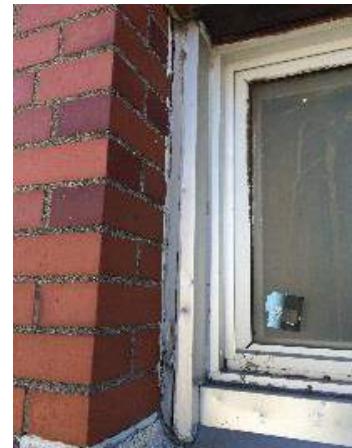
Photograph 3.11

7. The paint on the wood trim around the perimeter of the window infills is flaking and peeling off (typical). Upon visual inspection, there did not appear to be any rot in the wood. It is recommended all wood trim be scrapped, primed and painted within 1 year to prevent further deterioration. (See Photograph 3.11).

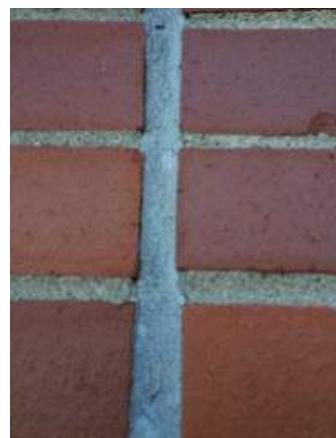
Photograph 3.12

8. Visible deterioration to the exterior sealants was noted throughout, primarily around windows and most portions of the 1959 building (See Photograph 3.12). The caulked control joints of the 1984 portion of the building were somewhat flexible and well bonded to the adjacent surface, however, they showed significant surface cracking and are presumed to be near the end of its life expectancy (See Photograph 3.13). It is recommended all exterior sealants be removed and the joints cleaned and re-caulked within 1 year.

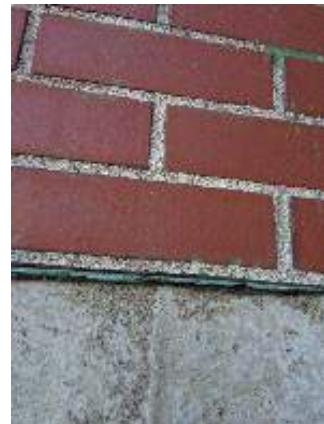
Photograph 3.17

11. There is evidence of thru wall flashings at the base of the brick masonry wall on the 1984 portion of the building (See Photographs 3.17 & 3.18). This is an indication the water that may enter behind the veneer is being properly drained.

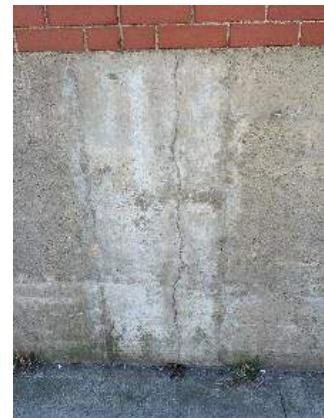
Photograph 3.19

12. Overall there did not appear to be significant cracking in the foundation wall on the 1984 portion of the building. A regular spacing of cracks was noted on the east side of the 1959 portion of the building (See Photographs 3.19 to 3.21). Visual evidence

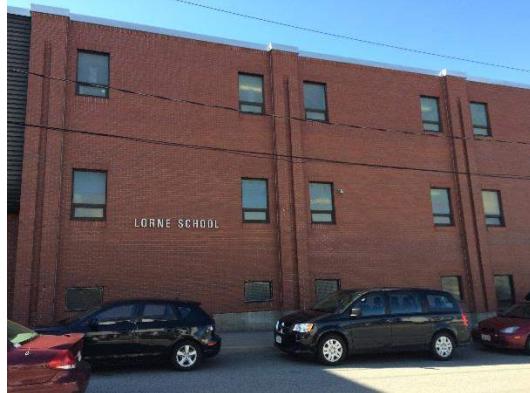
Photograph 3.22

Based on our visual observations, it is recommended all of the windows be replaced with insulated glazing units within 1-3 years.

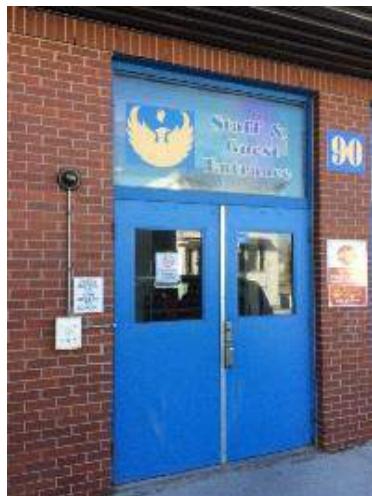
Photograph 3.26

None of the doors have powered operators for accessibility.

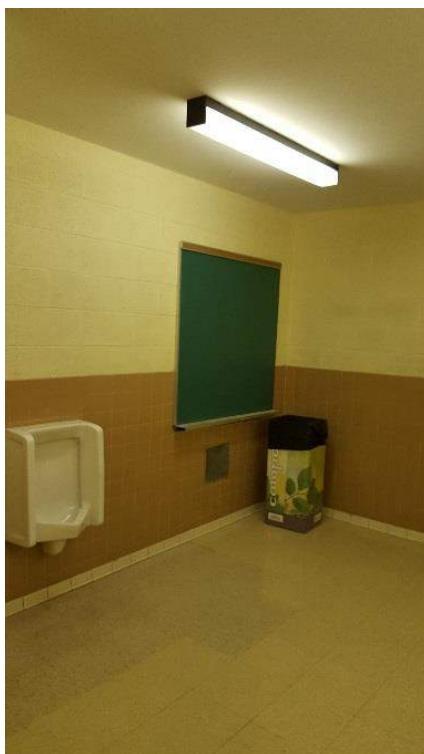
Photograph 4.1

Based on visual observations, some localized repairs should be carried out to the floor systems in the near future. In general, this work should include: remove 228mm x 228mm (9"x9") floor tile; minor mortar repair to the ceramic tile work in the washrooms; replace all rubber stair tread nosings; clean and repaint gymnasium floor and provide a thorough cleaning and continuing monitoring as part of an ongoing routine building maintenance program for all reaming floor systems.

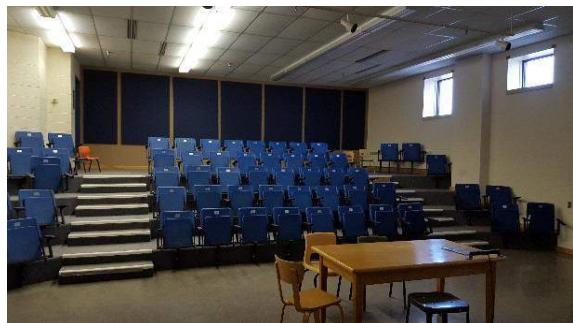
Photograph 4.5

5. A sheet good product is also found in the basement music room along with carpet on the stepped flooring areas (See Photographs 4.5 & 4.6). The sheet good appears to be in good condition, however, the carpet is showing signs of wear. Life expectancy of carpet can vary depending on grade, quality and application. Residential grades may have a life expectancy of 10 years while commercial grades may have a 20 – 40-year life cycle. The age and type of existing carpet is unknown. It is recommended to be replaced.

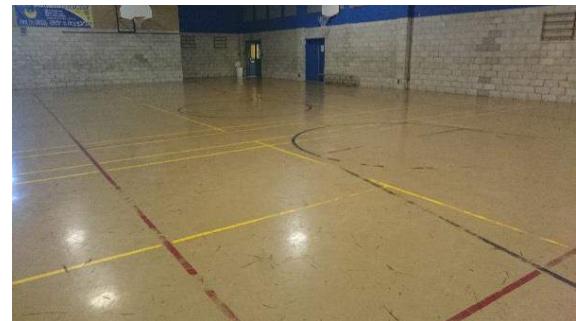
Photograph 4.8

7. The rubber floor in the gymnasium is thoroughly marked-up from use and the painted lines are worn and faded. A good cleaning and refinishing with new painted lines is recommended (See Photograph 4.8).
8. Stairs leading from the gymnasium to the second floor men's locker room and bonus room are painted concrete with tiled nosing. The paint is significantly worn off and some of the tile nosing pieces have chips in them (See Photograph 4.9). It is recommended to remove the tile nosing and replace it with a non-slip material such as textured rubber as well as to repaint exposed concrete surfaces.

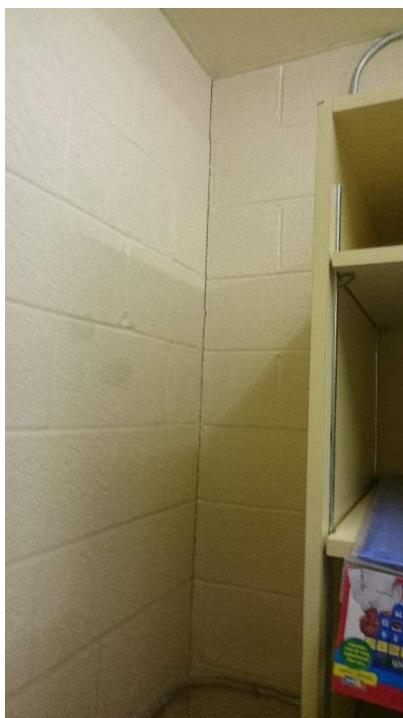
Photograph 4.10

Based on visual observations, some localized repairs should be carried out to the interior wall systems. In general, this work should include repair crack concrete block walls; introduce control joints to all concrete block walls; repoint joints in glazed concrete block wall and clean and repaint walls as part of an ongoing routine building maintenance program.

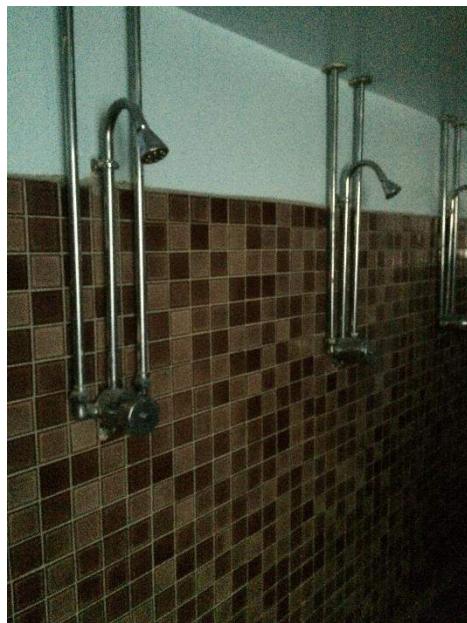
Photograph 4.16

3. The tiles in the washroom and shower room appear to be in good condition, however they could be considered outdated in style (See Photographs 4.16 & 4.17).

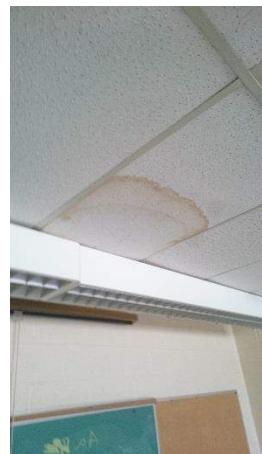
Photograph 4.18

Based on visual observations, some localized repairs should be carried out to the ceiling systems in the near future. In general, this work should include: further investigate potential water source by reviewing ceiling plenum space where possible; replace damaged acoustic ceiling tiles, repair damaged plaster ceilings. Areas where mold has been identified or suspected should be removed, cleaned of mold, and replaced immediately.

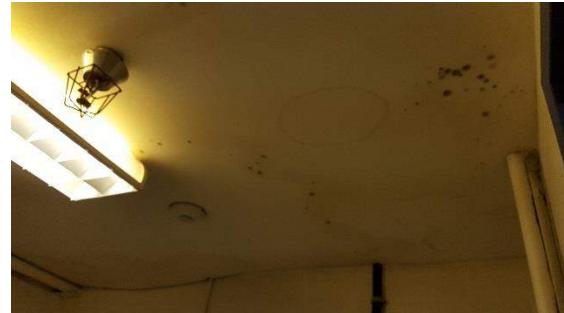
Photograph 4.19

2. Significant water damage and mould was noted in the mechanical and electrical areas in the basement (See Photograph 4.19) and should be repaired immediately.

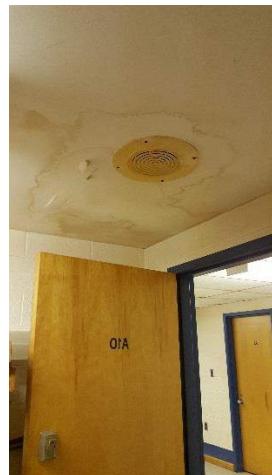
Photograph 4.20

3. Water staining was noted in basement ceilings where washrooms were located above (See Photographs 4.20 & 4.21)
4. The plaster ceilings in other areas of the 1959 portion of the building (such as in the locker rooms) appear to be in good condition (See Photograph 4.22). However, provided the age of the facility, it is not uncommon that such products could contain Asbestos. A hazardous materials testing report was not provided at the time of the review and as such this observation is only speculation. Further investigation is recommended prior to any modifications within the facility.

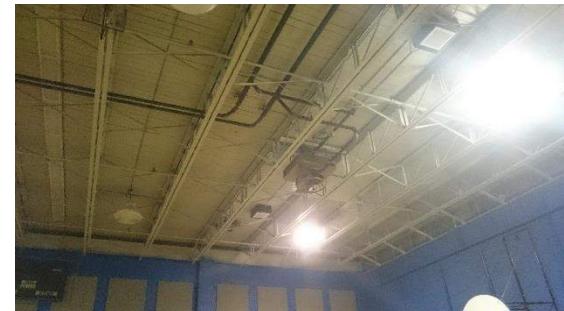
Photograph 4.23

5. The exposed ceiling in the gymnasium reveals wood slat decking supported by OWSJ. Based on visual inspection from the ground, the wood decking appears to be in good condition with no evidence of water staining (See Photograph 4.23)

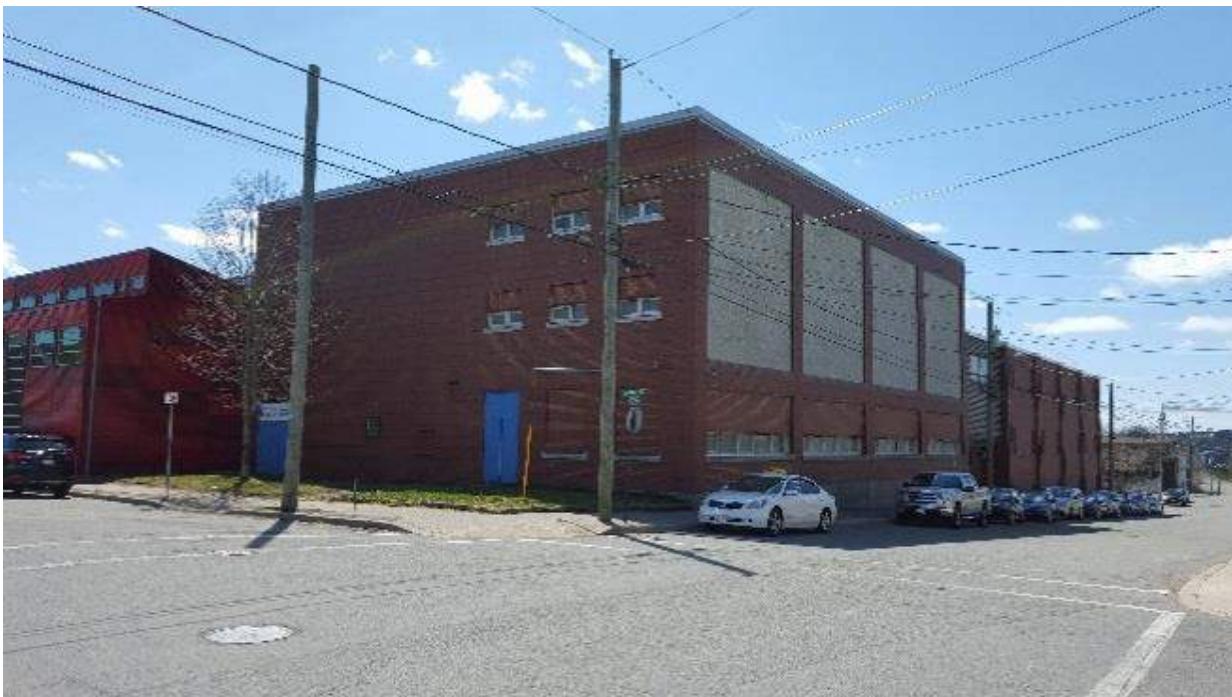
Photograph 5.1

The remaining south elevation of the Newman Street facility faces residential properties. The chain link fence surrounding the parking lot on the west side continues along this elevation and turns toward the building. The fence terminates at the corner of the 1959 portion of the facility thus preventing access between the Newman Street Facility and C.E. Nick Nicolle Community Center properties.

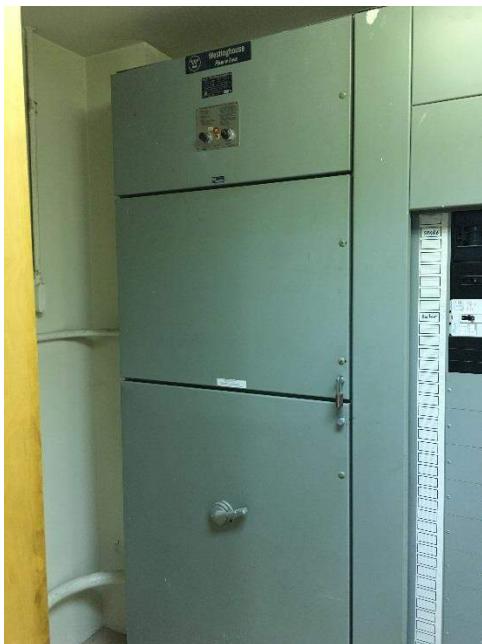
Photograph 6.1

Based on our observations, the main distribution equipment appears to be original to the building (30 years old). The equipment appears to be in fair condition but has reached its end of life. They may remain serviceable for several more years provided it is well maintained and serviced, however, replacement should be planned in the near future.

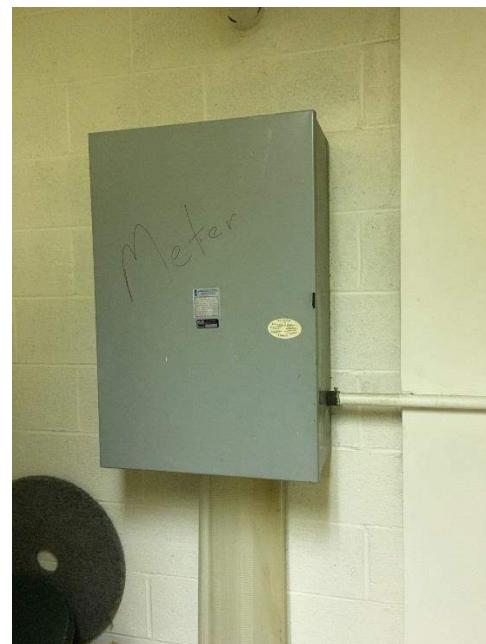
Photograph 6-2

The Newman Street Facility electrical service enters the building underground from an adjacent utility padmount transformer. This is a 1000A, 600V, 3-Phase service that connects to a Westinghouse service entrance board equipped with a 1000A main breaker (See Photograph 6.1). This panel feeds the boiler, elevator, mechanical equipment and the 600-120.208V step down transformer which feeds the remainder of the building. Metering includes a single utility meter for the entire facility (See Photograph 6.2).

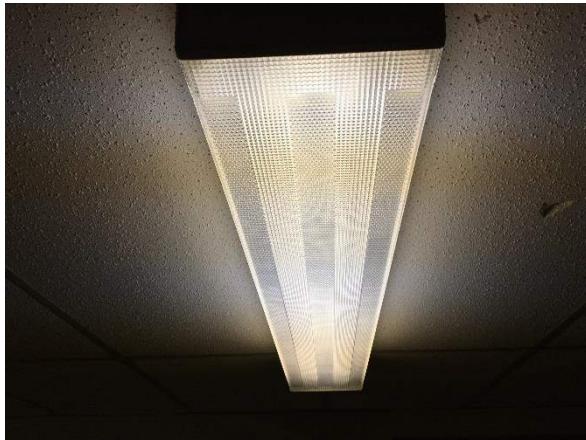
Photograph 6.3

Interior lighting for the building consists of a few different types of fixtures. The classrooms have surface mounted fluorescent wraparound fixtures (See Photograph 6.3) as well as surface mounted fluorescent parabolic wall washers (See Photograph 6.4). Lighting in the front lobby consists of recessed HID pot lights while lighting in the corridors consists of surface mounted fluorescent wraparound fixtures. The gymnasium has HID high-bay fixtures (See photograph 6.5) while the stage in the gymnasium has incandescent high-bay fixtures. Interior light fixtures appear to be original to the building and have reached end of life. All fluorescent light fixtures appear to have 40W T12 lamps with magnetic ballasts. It is recommended that all fixtures be replaced with LED equivalents for increased energy efficiency and lower operational costs.

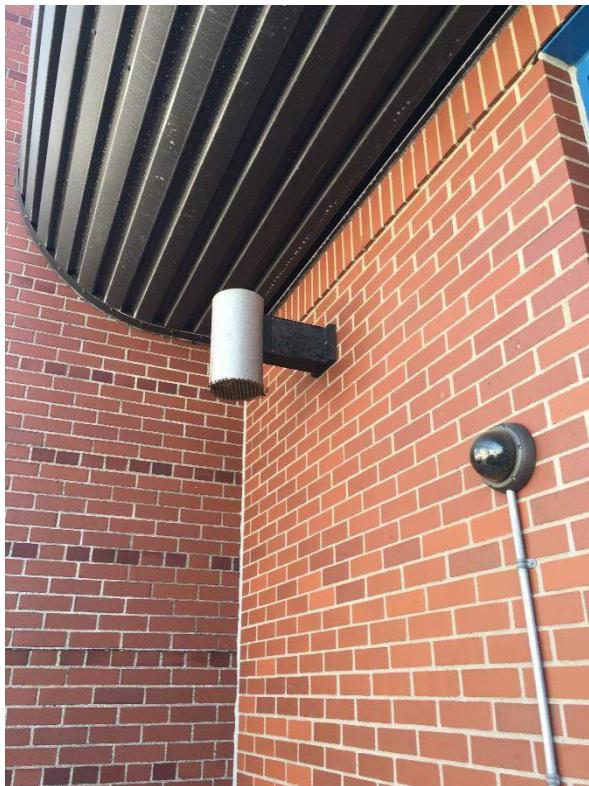
Photograph 6.6

Exterior lighting is minimal and is confined to above the entrances. Fixtures are wall mounted HID (See Photographs 6.6 & 6.7). Exterior fixtures appear to be original to the building and have reached end of life. It is recommended that they be replaced with LED fixtures.

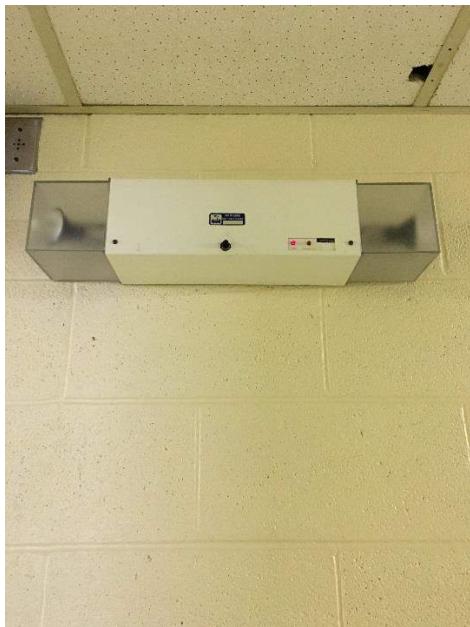
Photograph 6-8

Emergency lighting in the facility consists of battery units with dual MR16 heads (See Photograph 6.8). There are also single and dual remote head units located throughout the facility that are wired back to battery units (See Photograph 6.9). There is no emergency lighting in the boiler room, electrical room, and elevator machine room. Emergency lighting needs to be added within the next year. All battery packs and remote heads look to be in good condition and may remain serviceable for years to come with regular maintenance being done. Exit lighting is accomplished with red 'EXIT' signs located over all exterior doors, vestibule doors, and stairwell doors. It was noted in a couple locations in corridors that the surface mounted light fixtures impeded the view of the exit light at the end of the corridor. Exit signs are in good condition but no longer do they meet the latest edition of the National Building Code. Exit signs need to be replaced within the next 5 years.

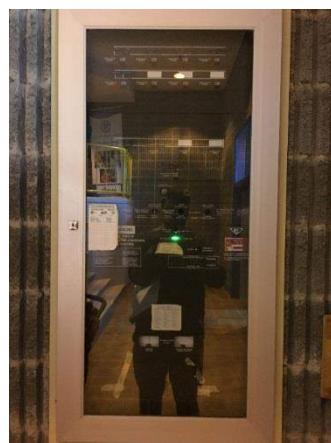
Photograph 6.10

The building contains an existing, conventional Edwards Custom 6500 fire alarm system (See Photograph 6.10). The main panel is located in the front lobby. The building is furnished throughout with pull stations, heat detectors and alarm bells and horns. There are two (2) pull stations missing on the stairwell near the front entrance. One on the second floor and one on the ground floor. Based on our observations, the fire alarm system appears to be operational and in good condition. However, care should be taken to ensure the system is inspected regularly. The fire alarm system has reach end of life and should be replace within the next 5 years.

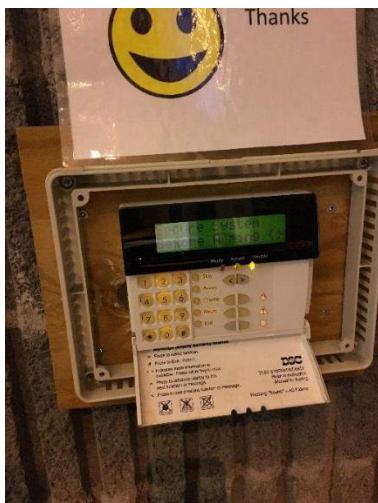
Photograph 6.11

The building has an intrusion alarm system with the main keypad located in the front lobby adjacent to the fire alarm panel (See Photograph 6-11). The system consists of motion detectors (See Photograph 6-12) and door contacts. The system appears to be in fair condition and may remain serviceable for years to come if maintained regularly.

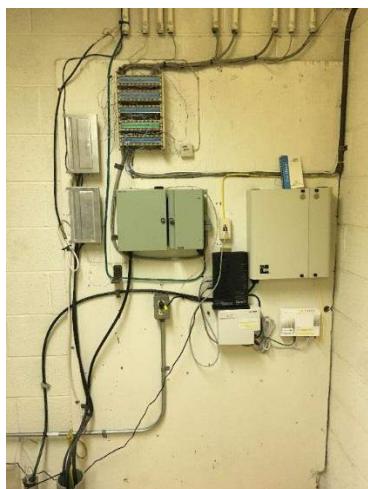
Photograph 6-13

The communications entrance is located in the main electrical room (See Photograph 6-13). Telephone and data outlets are located throughout the building. There is also a P.A. system installed in the building c/w speakers in all rooms and corridors as well as call switches in most rooms. The head-end equipment rack has been removed. CCTV cameras are located on the exterior of the building (See Photograph 6-14).
